Docket No. 217 – Development and Management Plan Inspection

Northeast Utilities Service Company Certificate of Environmental Compatibility and Public Need for the construction of a 345-kV electric transmission line and reconstruction of an existing 115-kV electric transmission line between Connecticut Light and Power Company's Plumtree Substation in Bethel, through the towns of Redding, Weston, and Wilton, and to the Norwalk Substation in Norwalk, Connecticut.

Date: November 10, 2005

Location: 115 kV Underground Route

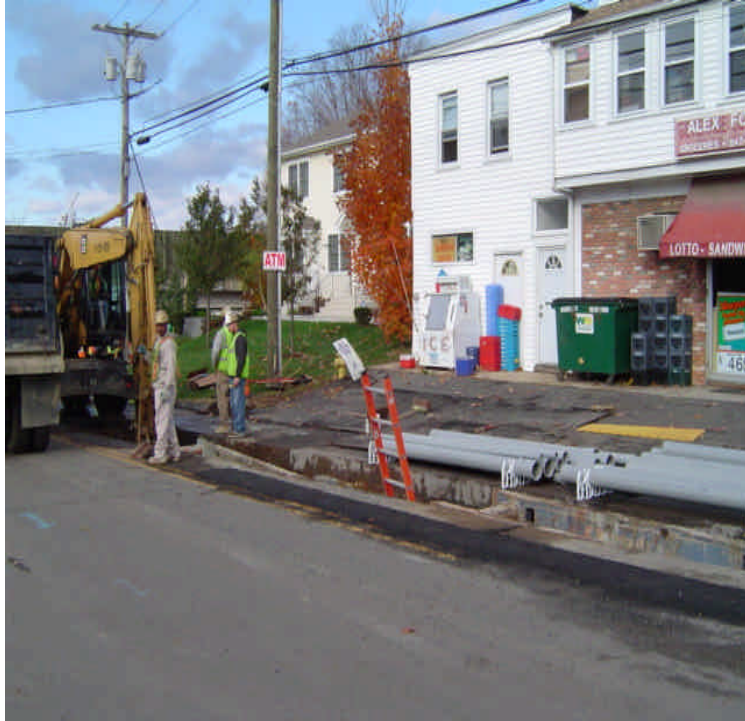
115kV (Broad Street): The photo on the left shows some of the last remaining sections of trenching along Broad St. Photo on the right shows catch basins installed with gutter buddies. Basins have various types of contractor and city-installed controls. 11/10/05

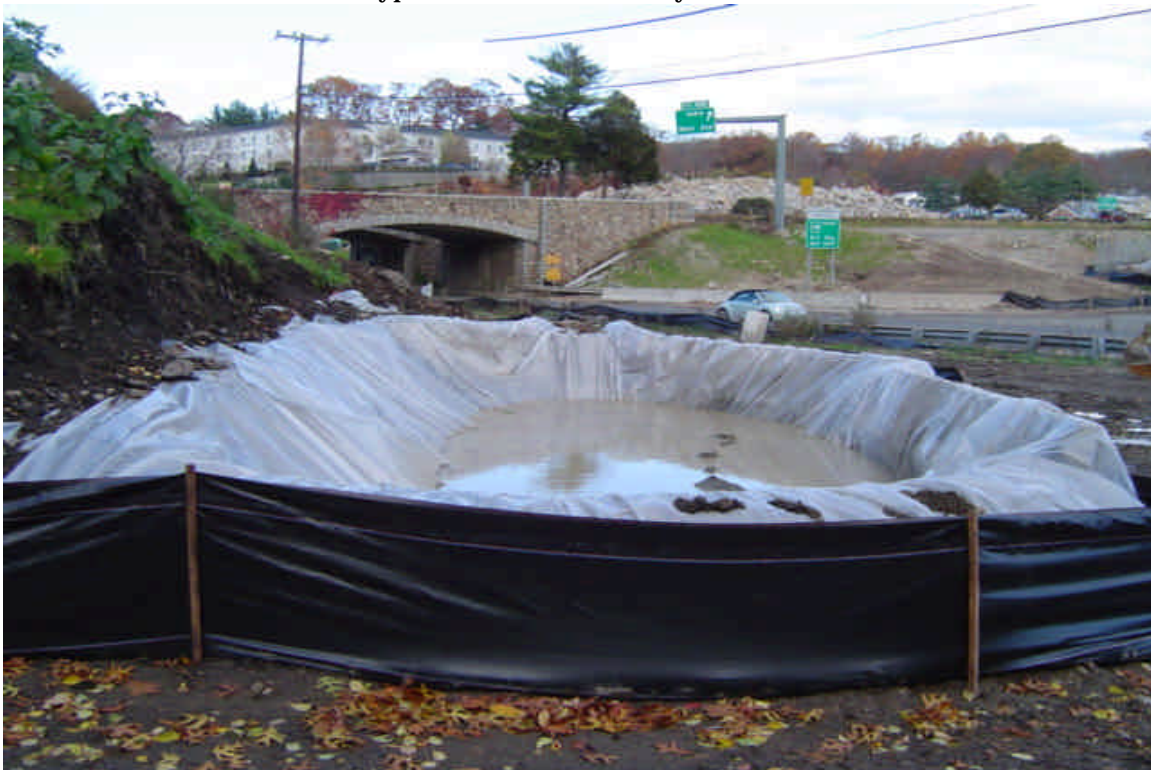
115kV (Route 7): View of the Merritt Cloverleaf concrete washout area which was recently installed with a plastic liner and repairs were made to the controls here. The area is in good shape. 11/10/05

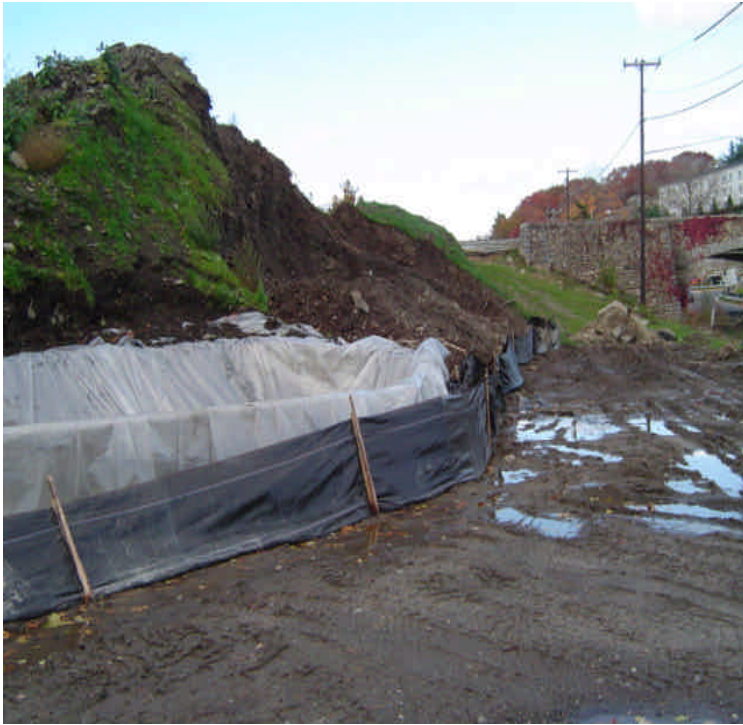
Photo on the left shows a further view of the repairs made to the washout area while photo on the right shows stone installed as a berm near the inlet. Concrete water no longer appears to be leaving the contained area due to the liner. 11/10/05

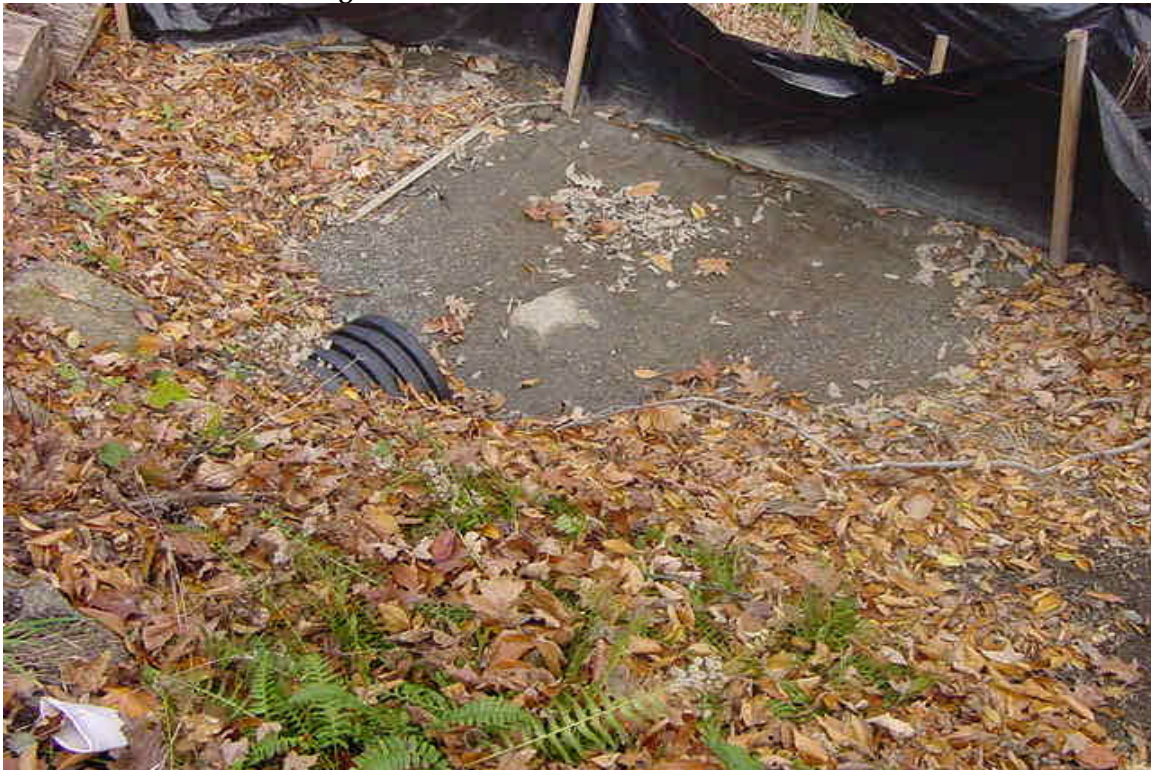
115kV (Redding Yard): The drain outlet from the yard remains well controlled and does not show signs that concrete washout is reaching this point. 11/10/05

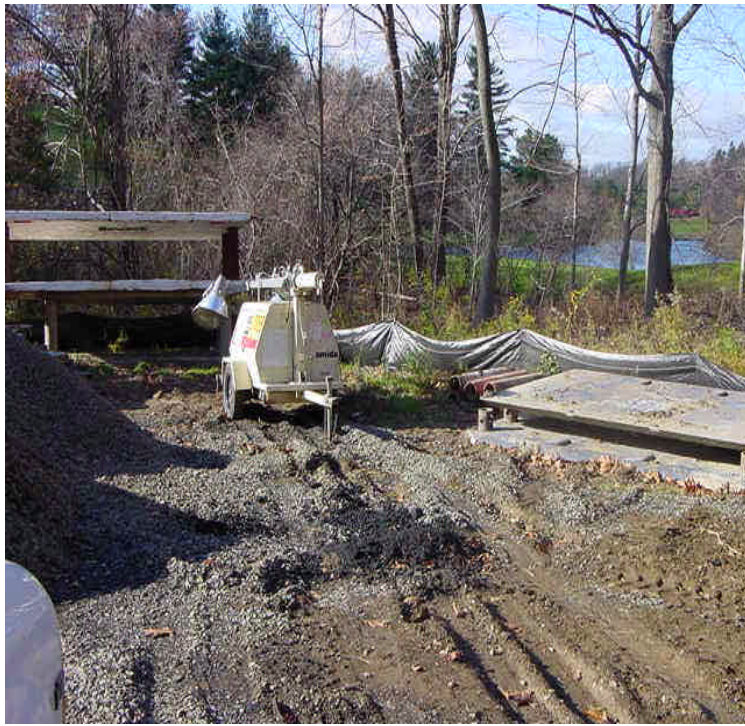
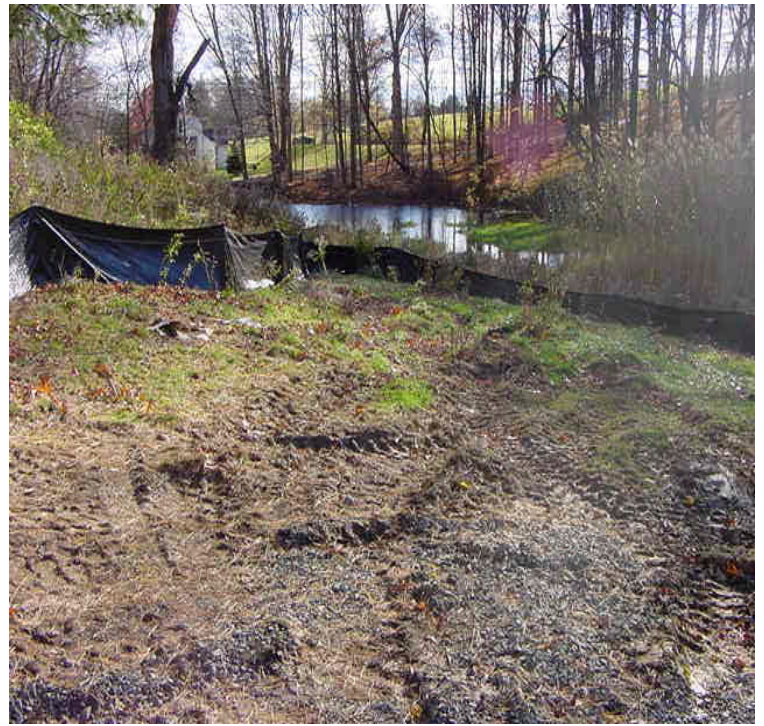
**115kV (Rt. 107) Both photos show the storage area adjacent to Redding Country Club. The silt was somewhat muddy and silt fence will remain until the area is no longer in use and is restored.
11/10/05**

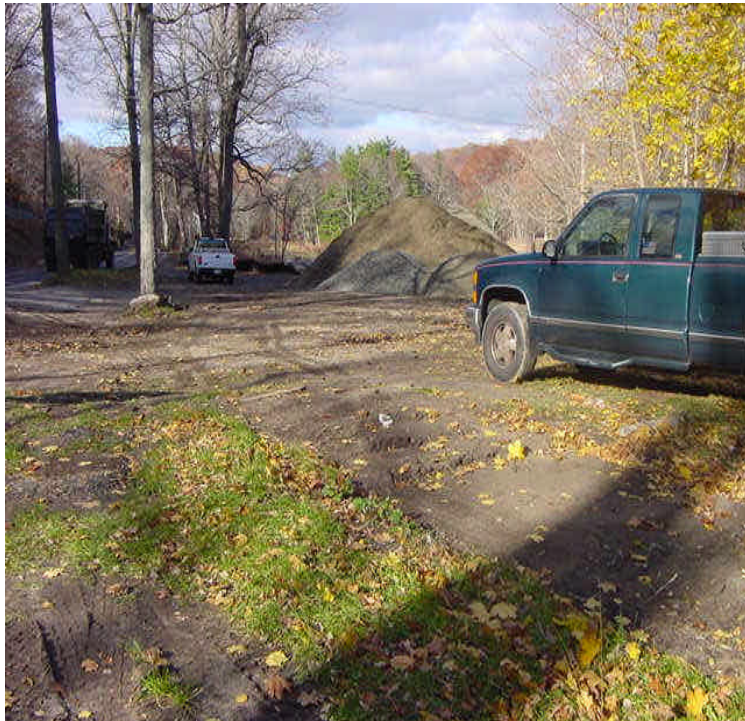
115kV: (Rt 58). The photo on the left shows the storage area at Putnam Park with some use continuing here. Photo on the right shows the Sunset Hill storage yard where trench boxes were placed too close to the silt fence. 11/10/05

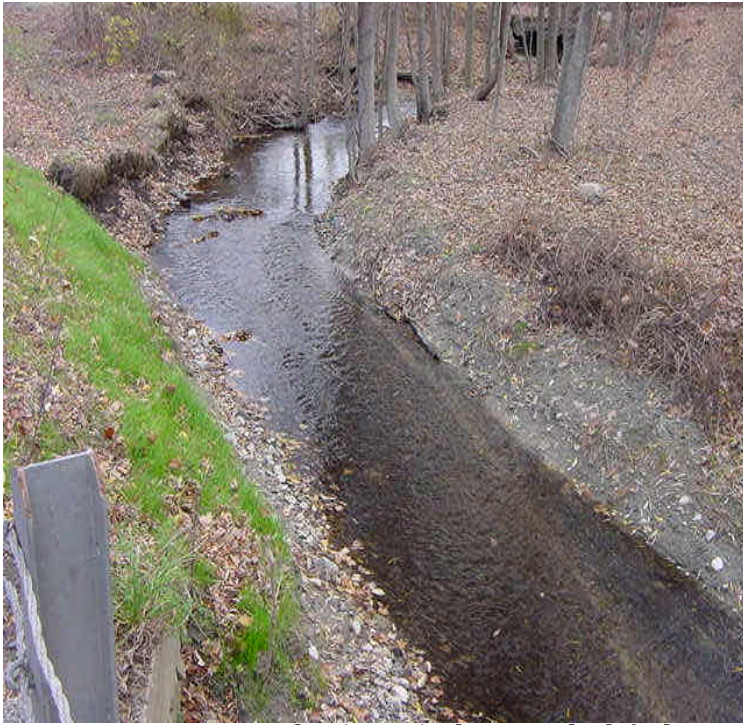
115kV (Rt. 58): Photo on the left shows the Hoyts Hill transition structure area where extraneous silt fence has now been removed and the area appears mostly stabilized. Photo on the right shows the stream at Sara's Way still running clear. 11/10/05.

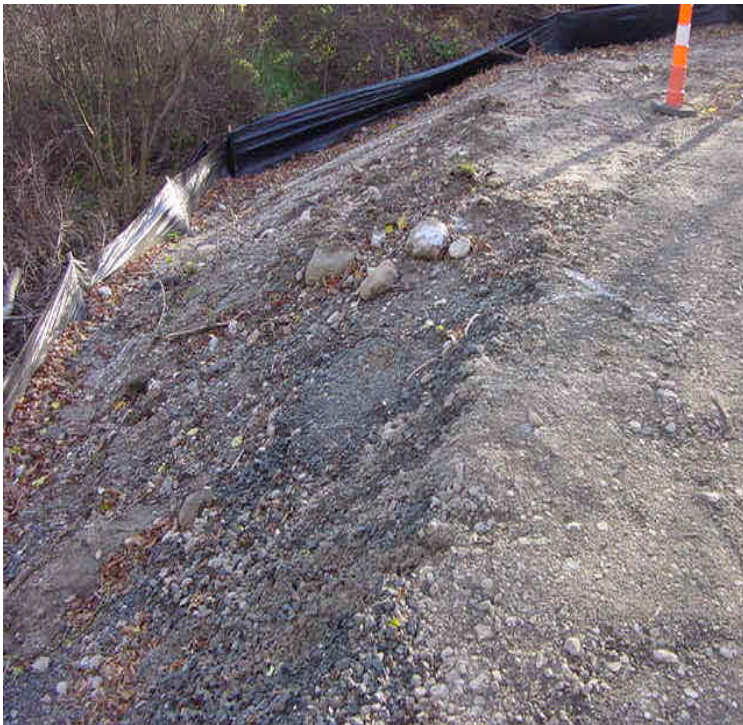
115kV (Bethel Ed. Park): Photo on the left shows the slope near the southern end of the ROW. It remains in good condition even following the rains earlier. The photo on the right shows a spot along the ROW moving south where a washout has caused some sedimentation. 11/10/05
